# **Facilities Master Planning Report**

**Troy Public Schools**

**Junior- Senior High**

**April, 2010**

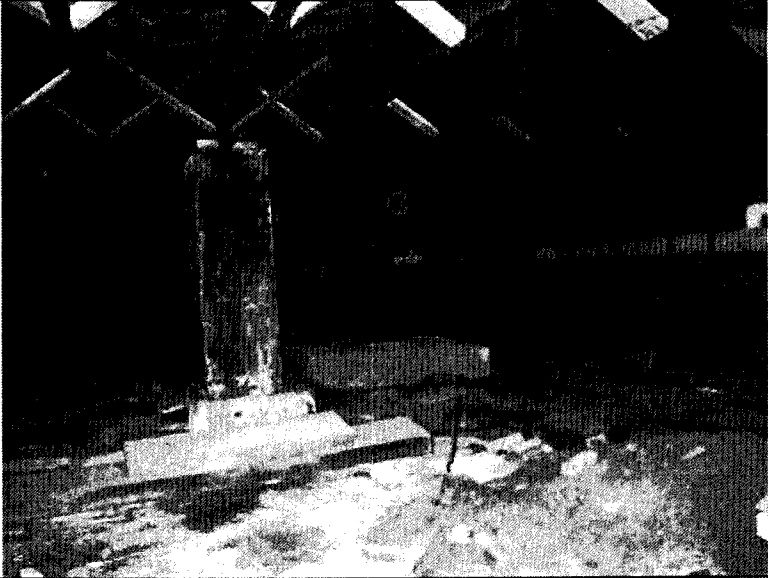
Item # 1G-HS	Description
Component:	Supporting floor structure
Location:	Gymnasium
Deficiency:	"Soft spots" in the gym's playing floor surface; Probable combination of inadequate post-and-beam structural support spacing and poor connection of subfloor to floor joist fastening.
Consequence:	Poor playing floor performance
Photo #1G-HS

Recommendation:	Add intermediate post and beam support structure or adjustable steel support columns on cast in place concrete pier foundation. The column will be installed on a solid concrete base which is placed on engineered fill. The column is secured to both the concrete base and to the bottom of the beam or joists above. The support column adds stability and decrease the deflection of the joist.
Cost Estimate:	\$15,069
Priority:	Low

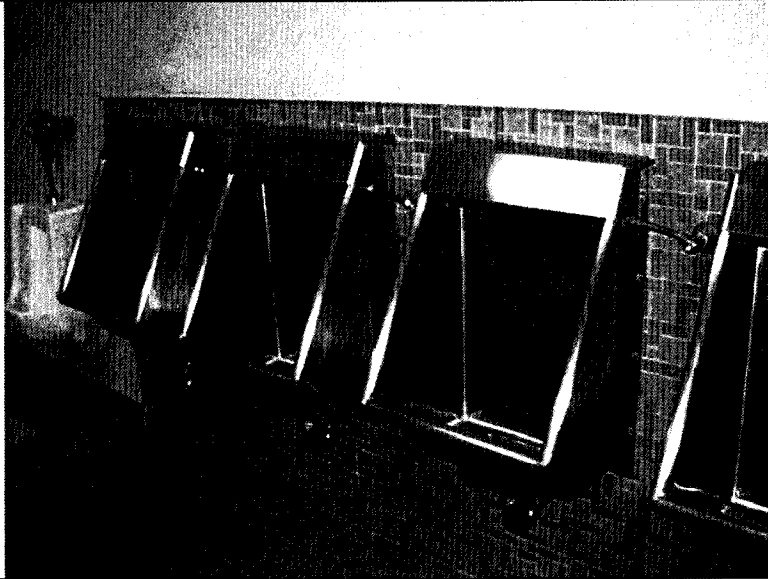
Item # 5G-HS	Description
Component:	4 Stainless steel urinals
Location:	Boy's restroom, original high school building
Deficiency:	No mechanical flush valve. Type of fixture allows water runs continuously with no means of shut off. Typical of all 4 fixtures.
Consequence:	Waste of water, higher water bills than necessary
Photo #5G-HS

Recommendation:	<p>Remove and replace existing stainless steel urinals with new low flow (1 gpf or less) automatic flush valve urinals.</p> <p>Urinals, like toilets, use large amounts of water. Before the advent of low-flow models, many urinals required 2-3 gallons of water per flush. At the Troy High School the existing stainless steel urinals have a continuous water wall wash that far exceeds the 2-3 gallons of water per flush. Modern low-flow models all require less than 1 gallon per flush. When coupled with a touchless, automatic control valve, water savings produced by low-flow urinals is even greater.</p> <p>Touchless controls for restroom toilets and urinals have been widely promoted as a means of improving hygiene and promote water conservation in restrooms. By automatically flushing the units after use, automatic controls prevent users from over flushing.</p> <p>If we make a conservative estimate that the four current urinals have one (1) gallon per minute continuously flowing through the urinals. It can be calculated that the water used by these four urinals alone is 525,600 gallons per year.</p> $1 \frac{\text{gallon}}{\text{minute}} * 60 \frac{\text{min.}}{\text{hour}} * 24 \frac{\text{hours}}{\text{day}} * 365 \frac{\text{days}}{\text{year}} = 525,600 \frac{\text{gallons}}{\text{year}}$

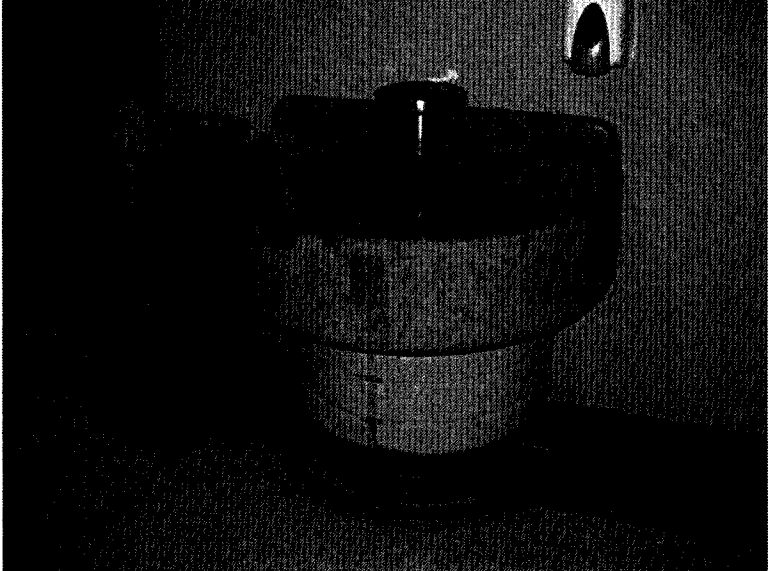
Item # 6G-HS	Description
Component:	Multi-user style lavatory basin(s)
Location:	Boy's restroom, girl's restroom, original high school building
Deficiency:	Poor water-flow, no hot water recirculation
Consequence:	Require continuous spray adjustment, cold water only
Photo #6G-HS

Recommendation:	<p>Remove and replace existing lavatory basin with modern style sensor operated fixture. Install hot water recirculation line or a point of use water heater.</p> <p><b>Low-flow faucets.</b> A standard lavatory sink faucet has a flow rate of 2.5-5 gpm. Redesigned low-flow faucets have reduced this flow rate to 1.5-2.5 gpm while maintaining an adequate flow rate for hand washing. The design of the aerator installed in the outlet mix air into the water as it leaves the faucet, reducing both the flow and the amount of splashing, while increasing wetting efficiency.</p> <p><b>Touchless controls.</b> Touchless controls for restroom faucets have been widely promoted as a means of improving hygiene in restrooms. An infrared sensor detects a user's hands under the faucet and turns on the water. Removing the hands turns off the water flow. Unlike timed and other automatic controls, touchless controls limit water flow.</p> <p><b>Point-of-use water heaters.</b> Traditional building designs rely on a central water-heating system. A centrally located boiler generates hot water, which is distributed through insulated piping. Larger buildings use circulation pumps and large central storage tanks to improve system performance.</p> <p>Systems designed to generate hot water at the point of use employ multiple, smaller water heaters located throughout a facility. Generating hot water at the point of use reduces distribution losses and, just as importantly, water requirements. When hot water is generated in a central system, even in</p>

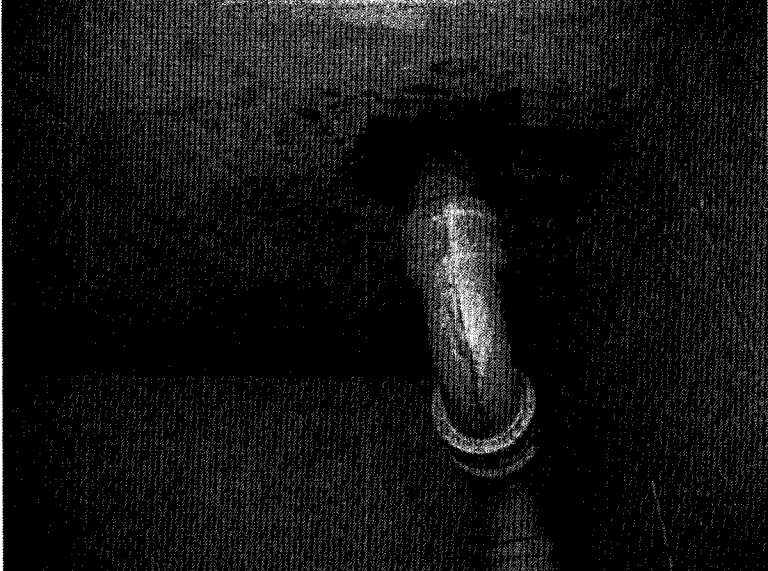
Item # 8G-HS	Description
Component:	Roof drain/roof penetration
Location:	365 sq-ft roof section over weight room
Deficiency:	Significant water damage at interior ceiling in the vicinity of the roof drain penetration (northwest corner of room).
Consequence:	Water damage to building interior ceilings, walls and floor
Photo #8G-HS

Recommendation:	Investigate cause of roof leakage at roof penetration. Repair and reseal roof as Required. This is an ongoing issue that needs to be monitored. Regular maintenance on the roof will help reduce these issues.
Cost Estimate:	--
Priority:	Medium

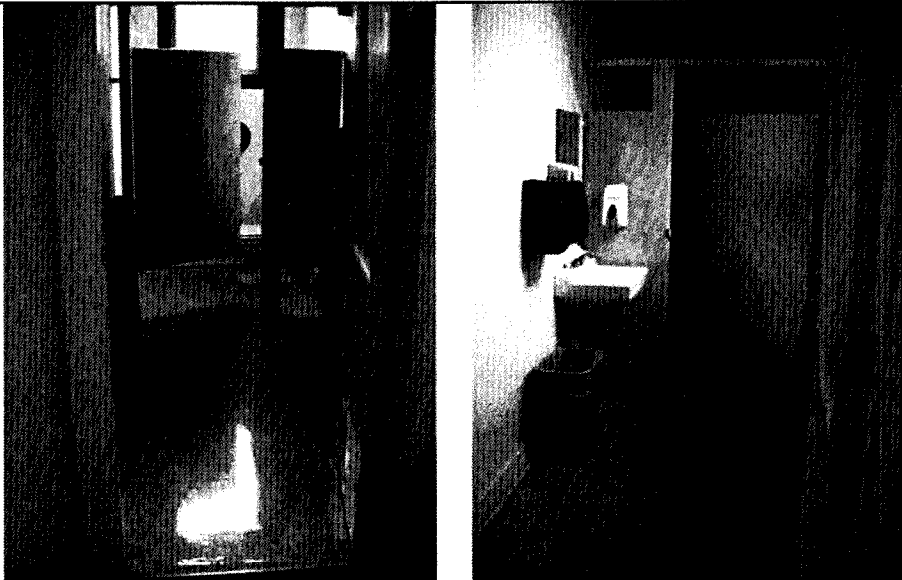
Item # 2G-JH	Description
Component:	Handicap accessible and general restrooms
Location 1:	Junior high basement
Location 2:	Junior high southwest entrance adjacent to the auditorium
Deficiency:	The school's existing restroom facilities are currently located in the basement of the 3-level building. A single boy's handicap stall is located in a locked storage closet adjacent to the boy's restroom. The location and configuration of the restrooms do not meet current building codes for accessibility and are not conveniently located for practical use. The quantity of restroom fixtures is not sufficient for the student enrollment and staff.
Consequence:	Non-code compliant, Inconvenient
Photo #2G-JH

Recommendation:	Provide new restrooms at alternate, handicap accessible location at Junior high school main level. New restrooms shall be ADA compliant, access fixtures and hardware. As identified in Montana Department of Commerce Quality Schools project grant application.

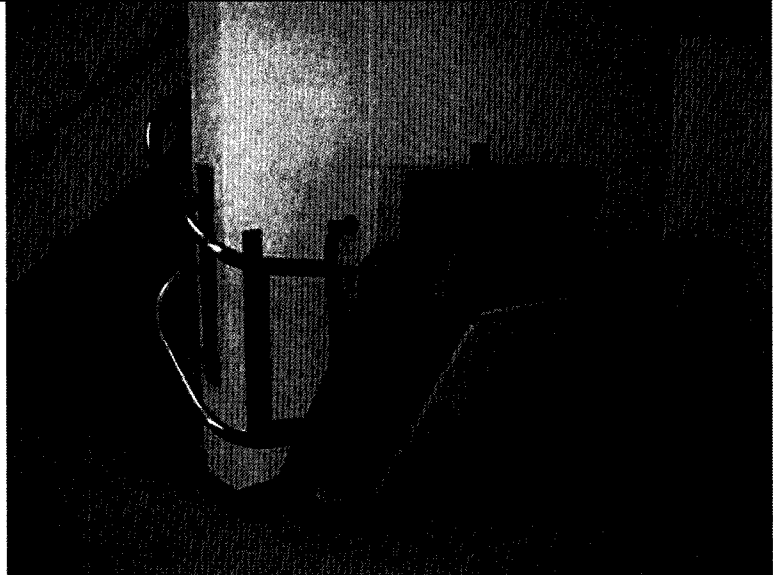
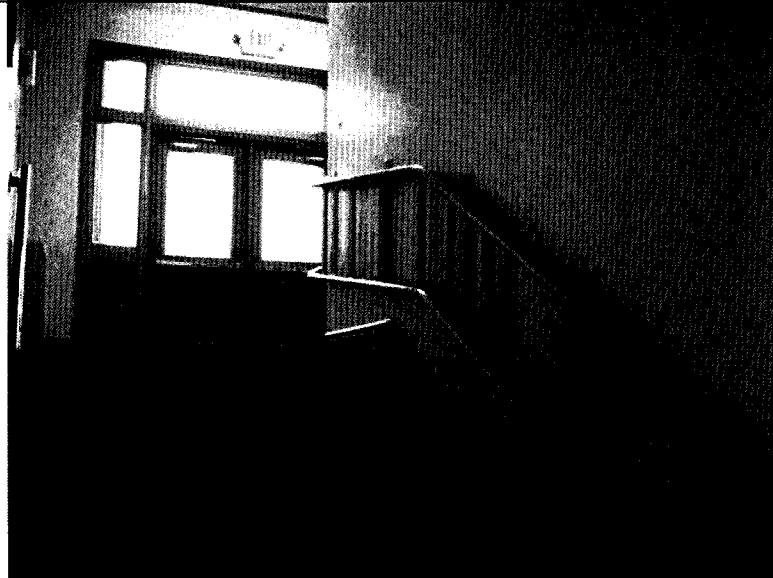
Item # 3G-JH	Description
Component:	Platform, stair climber wheelchair lift
Location:	Central three-story staircase
Deficiency:	Lift is not operational, lift is not code compliant in the U.S., replacement parts are not available.
Consequence:	The school does not have ADA (handicapped access) to the restrooms on the basement level. The school does not have ADA access to the classrooms at the upper level. Furthermore, the existing ADA restroom does not meet ADA requirements as a truly compliant ADA restroom.
Photo #3.1G-JH

Recommendation:	Replace wheel chair lift with an elevator. Identify location for the new elevator. As identified in Montana Department of Commerce Quality Schools project grant application.
Cost Estimate:	\$1,175,270
Priority:	High

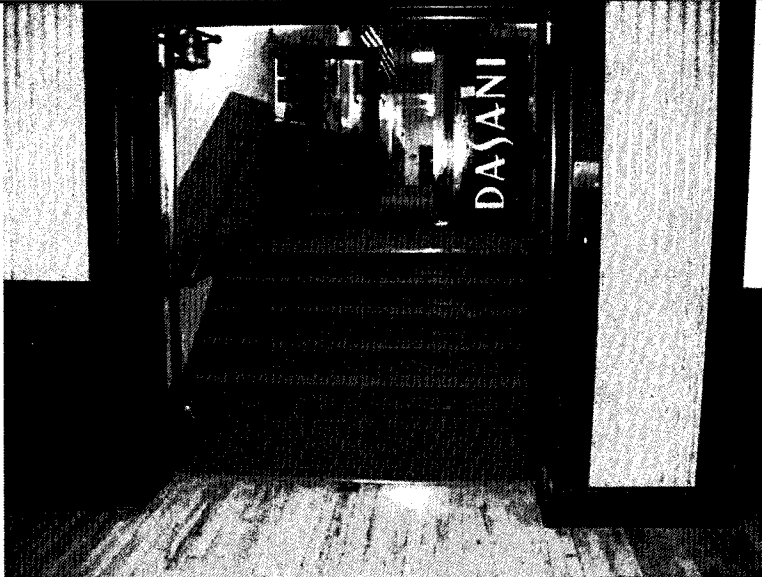
Item # 4G-JH	Description
Component:	Handicap Access to Entire Facility (Interior Corridor Staircase)
Location:	Main level corridor to auditorium
Deficiency:	No ADA access from main level to auditorium, cafeteria and restrooms. The existing Junior High School was designed without disabilities in mind. The auditorium and lunch room are separated from the rest of the school by a flight of stairs.
Consequence:	Arrangement does not meet ADA access requirements. Wheelchair access from the school's main level to the, auditorium, cafeteria and restrooms is from exterior of the building. Handicapped person must exit the classroom wing at the southwest corner of the building and re-enter at the auditorium.
Photo #4G-JH

Recommendation:	Replace wheel chair lift with an elevator. Identify location for the new elevator. As identified in Montana Department of Commerce Quality Schools project grant application.

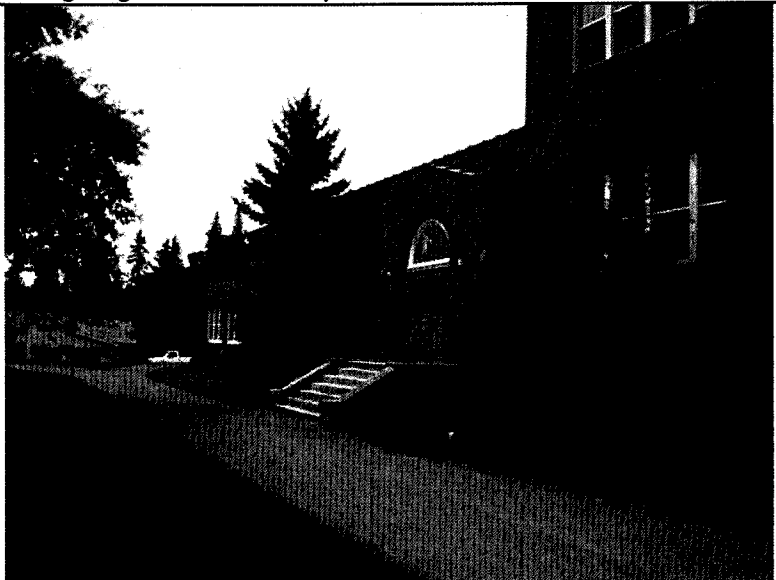
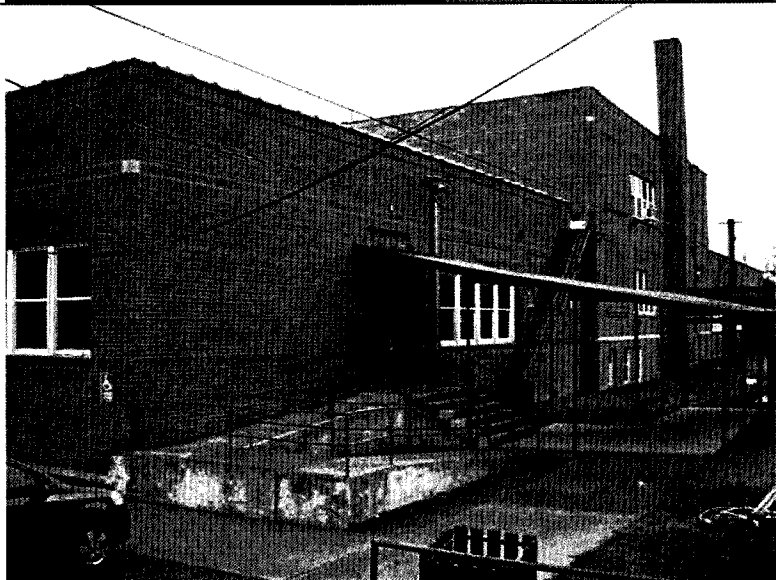
Item # 5G-JH	Description
Component:	Single point entry
Location 1:	Main entrances on Highway 2 side of the building
Deficiency:	Lack of single, supervised entrance to the facility. The original front entrances to the school are not adjacent to the facilities parking on the opposite side of the school.
Consequence:	The existing layout does not give administration control over who is coming and going into the facility.
Photo #5.1G-JH

Recommendation:	Add new entry on West side, adjacent to parking lot facility to serve as a single point entry. Restructuring or re-planning of interiors spaces will be required to localize the flow of traffic through the administrative area. Refer to Montana Department of Commerce Quality Schools project grant application.
Cost Estimate:	\$1,175,270
Priority:	Low

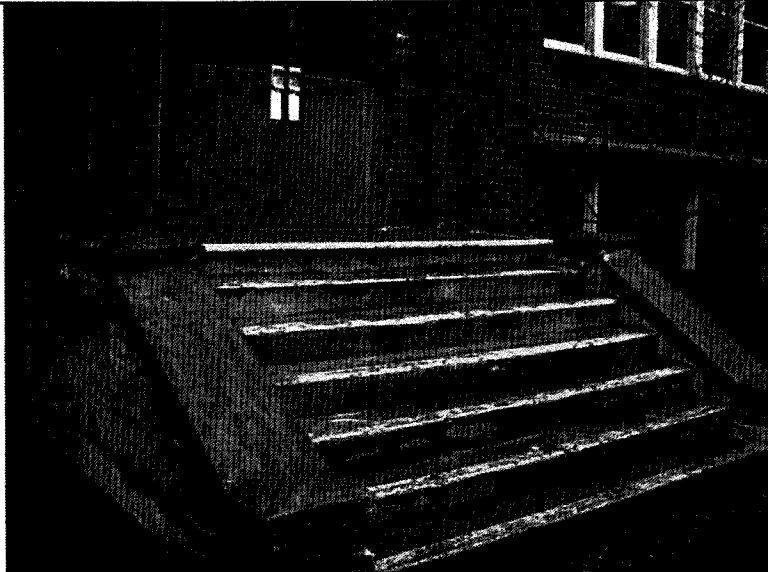
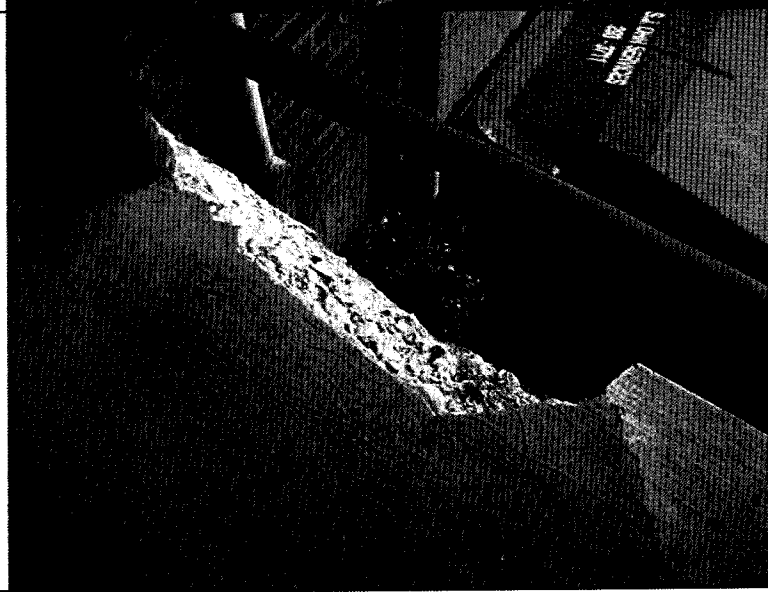
Item # 6G-JH	Description
Component:	Exterior concrete entry staircases
Location 1:	Front entry (east)
Location 2:	Auditorium entry (east )
Location 3:	Handicap entry ramp/stair (north)
Deficiency:	Concrete stairs are crumbling and deteriorating
Consequence:	Potential tripping hazard and restricted handicap access.
Photo #6.1G-JH

Recommendation:	Construct new cast in place concrete stair with continuous guard rail. Continuous guard rail shall extend the length of the staircase beyond last tread of staircase.
Cost Estimate:	\$16,244
Priority:	Medium

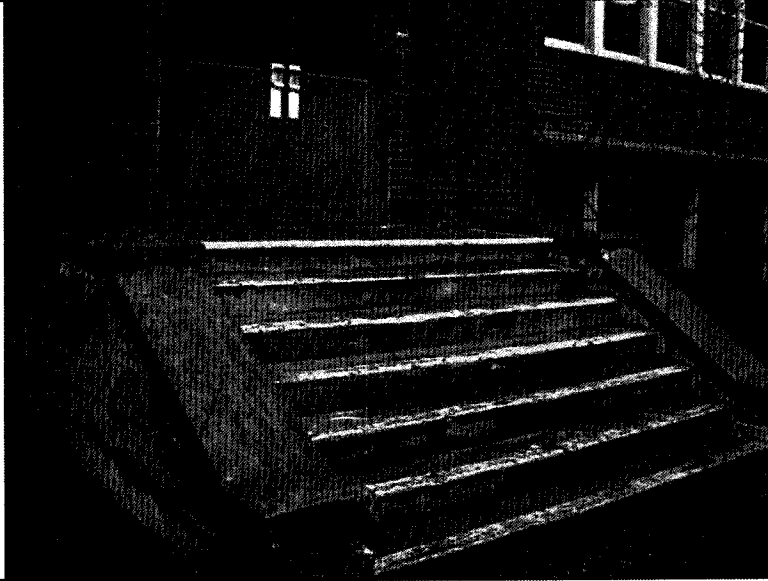
Item # 7G-JH	Description
Component:	Exterior entry staircase
Location 1:	Front entry (east)
Location 2:	Auditorium entry (east )
Deficiency:	Handrails do not extend past the last tread of the staircase.
Consequence:	Not ADA code compliant, safety hazard
Photo #7G-JH

Recommendation:	Construct new continuous guard rails to extend beyond last tread of staircase.
Cost Estimate:	\$4,284
Priority:	Medium

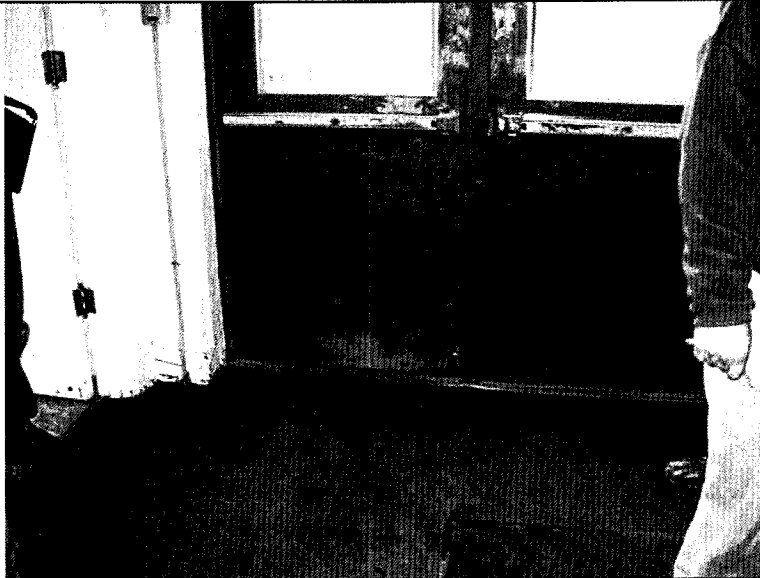
Item # 8G-JH	Description
Component:	Exterior entry doors
Location 1:	Front entry (east)
Location 2:	Auditorium entry (east )
Location 3:	Auditorium entry (west )
Location 4:	Handicap entry (north)
Deficiency:	Poor quality, poor operational doors. Some of the components are dysfunctional, but the doors are intact. Some of the door frames are split or separating from the wall. Doors are old as is the panic hardware. Lack of sufficient weather stripping and poor seals. All entry doors have antiquated, non-ADA compliant door hardware
Consequence:	Door do not close or latch properly, slam shut hard, mild safety hazard. Lack of weather stripping and poor seals result in wasted energy due to air infiltration.
Photo #8G-JH

Recommendation:	Replace existing doors and frames with modern energy efficient doors with weather stripping, and ADA panic hardware. Replacing the doors will help reduce energy lose, provide for better security and access, function better, and provide an aesthetic improvement.

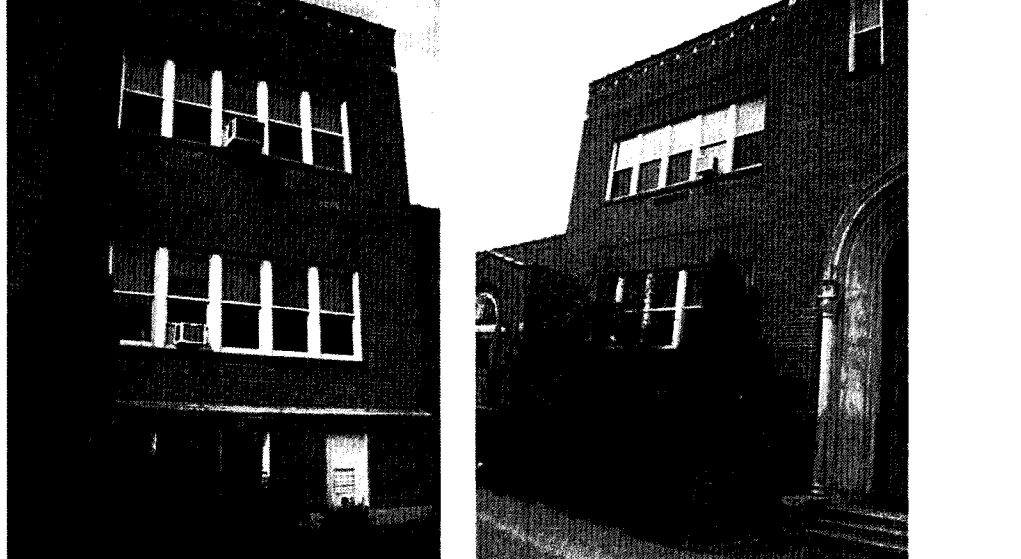
Item # 9G-JH	Description
Component:	Furred window openings
Location:	Multiple window openings throughout the entire building
Deficiency:	Windows are partially or completely covered
Consequence:	Unsightly appearance, Reduced natural light transmission
Photo #9G-JH

Recommendation:	<p>Remove and replace furred covered windows with a combination of thermally efficient double pane glass and a high R-Value translucent Kal-Wall system.</p> <p>The furred windows would be replaced with a high-performance translucent "Kalwall®" building panel assembly. The Kalwall panels offer superior thermal performance (R-Values as high as 20) while allowing light to diffuse into the building. This diffused light provides natural day-lighting without sacrificing energy efficiency. A side benefit of the Kalwall panels would be the improvement in natural "day-lighting". In addition to brightening up the space, day-lighting can assist with reducing energy cost by minimizing the need for electrical lighting.</p> <p>The window replacement will also improve the building aesthetics. Restoring the building to its historical appearance.</p>

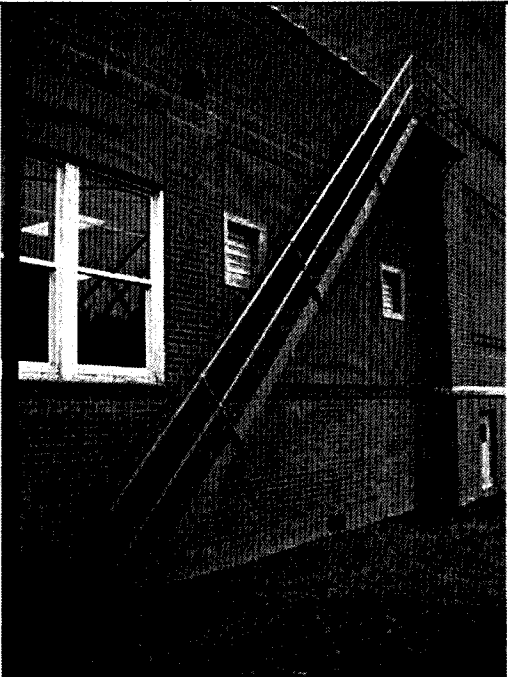
Item # 10G-JH	Description
Component:	Third floor fire escape
Location:	Northwest corner of Junior High Building
Deficiency:	Fire escape staircase is not sufficiently fastened to structure
Consequence:	Potential collapse of staircase under excessive live loading
Photo #10G-JH

Recommendation:	Evaluate and identify proper securing of existing emergency staircase to building structure.
Cost Estimate:	\$910
Priority:	High

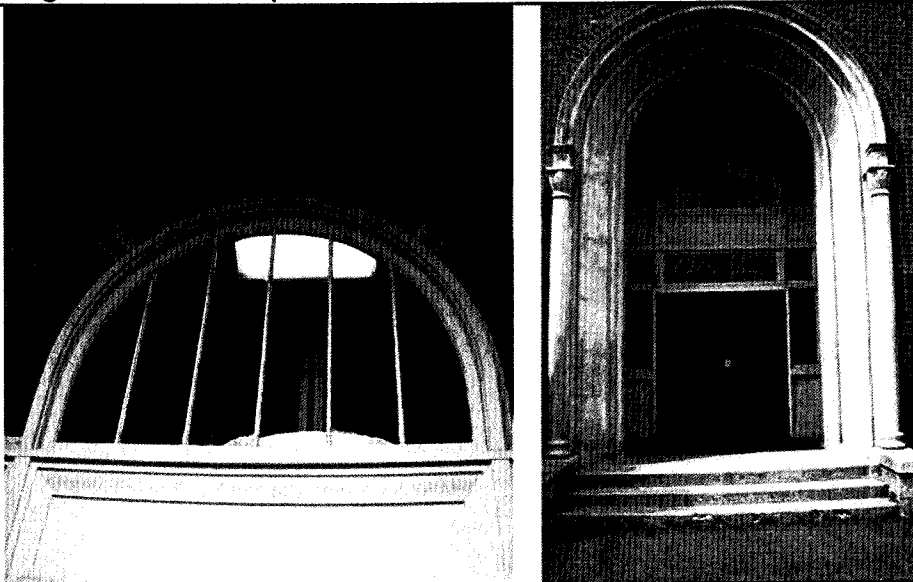
<b>Item # 11G-JH</b>	<b>Description</b>
<b>Component:</b>	Single pane windows at building entryways
<b>Location 1:</b>	Front entry (east)
<b>Location 2:</b>	Auditorium entry (east)
<b>Deficiency:</b>	Single pane windows.
<b>Consequence:</b>	Single Pane window provide minimal thermal resistance
<b>Photo #11G-JH</b>

<b>Recommendation:</b>	<p>Remove and replace single pane windows with custom thermally efficient double pane glass.</p> <p>The proposed replacement for the entry would be to replace the single pane windows with double-pane low-e glass. The new windows would improve the thermal efficiency of the glass and window framing.</p> <p>Custom windows would maintain the aesthetics of the historic building.</p>
<b>Cost Estimate:</b>	\$8,723
<b>Priority:</b>	Low

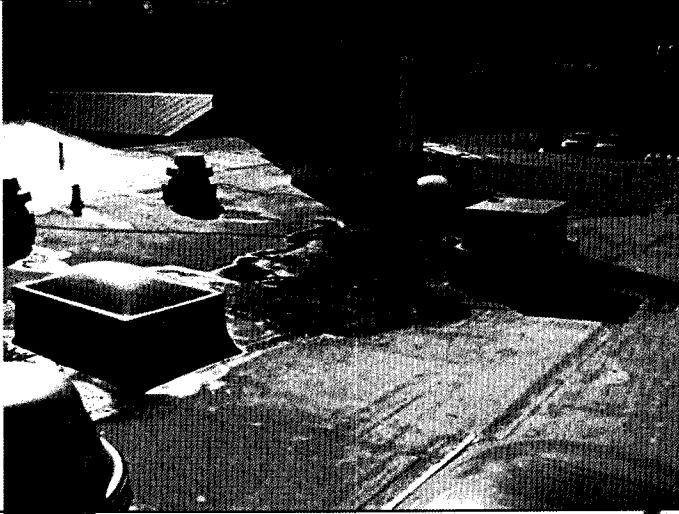
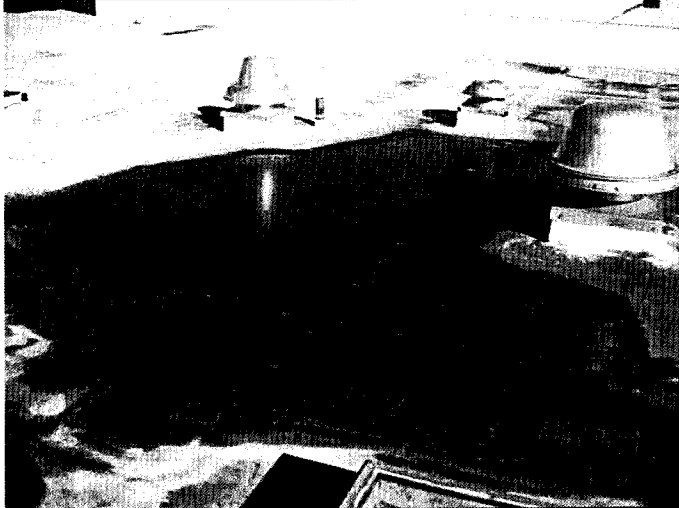
Item # 1G-EL	Description
Component:	Building roof system
Location:	Refer to Roof Investigation Survey prepared by Benchmark Roof & Pavement Consultants, August 2007
Deficiency:	Various water ponding problems, Punctured/damaged roof membrane, Missing roof drain strainers, Cracks in skylights (Refer to roof survey report and roof plan R-1)
Consequence:	Some observable water leakage and other potential water leakage
Photo #1.1G-EL

Recommendation:	Follow Recommendations as outlined in Roof Investigation Survey prepared by Benchmark Roof & Pavement Consultants, August 2007. Refer to Report and Appendix roof plan R-1. Annual or semi-annual maintenance is required to extend the life of the roof.
Cost Estimate:	--
Priority:	Medium

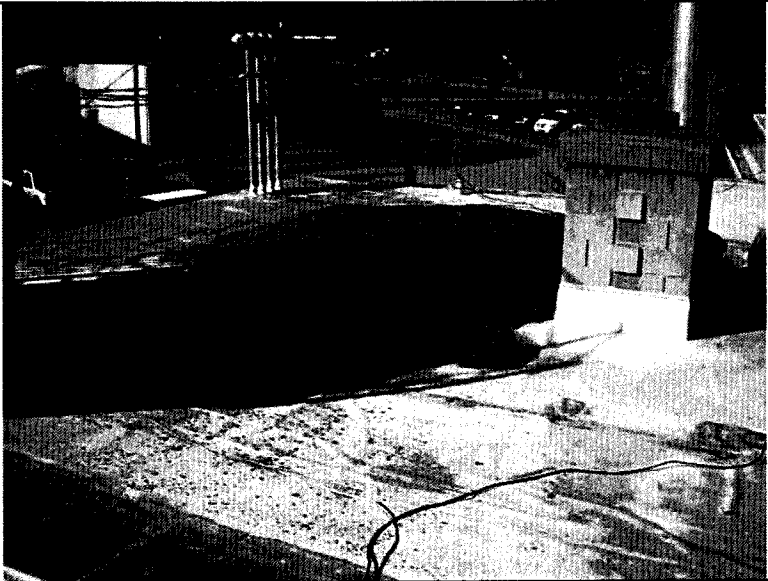
Item # 2G-EL	Description
Component:	Structural settlement of roof system
Location:	Roof over boiler room
Deficiency:	Structural settlement of supporting roof elements due to water-weight associated with roof ponding and/or increased loading of structural roof members from suspended mechanical/electrical services in boiler room below. Observable cracking and/or separating of plasterboard ceiling sheeting in boiler room.
Consequence:	Potential roof collapse in boiler room under heavy snow loading
Photo #2G-EL

Recommendation:	<p>Preliminary recommendation is to have a Licensed Structural Engineer to conduct a site evaluation and structural investigation of the roof and support structure.</p> <p>Reconstruction Recommendation: Demo existing roof and support structure above boiler room and reconstruct new engineered roof support with new roof drainage, insulation, membrane, and fire rated ceiling.</p>

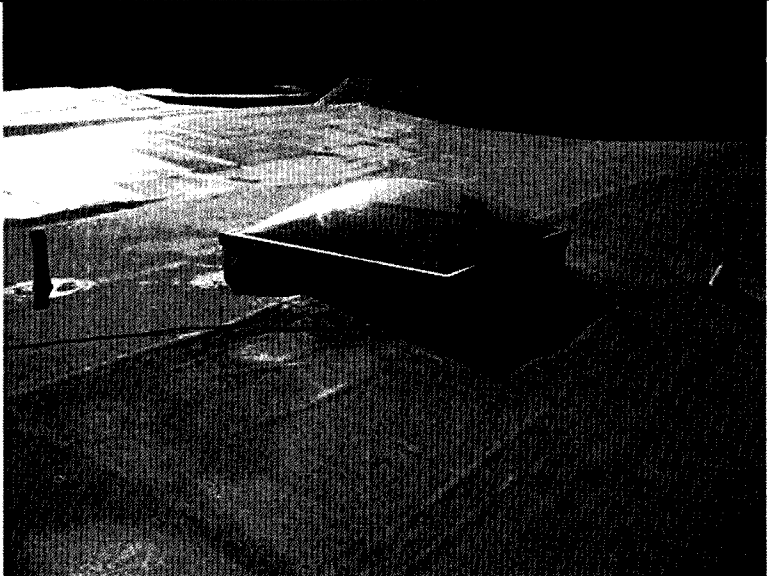
Item # 3G-EL	Description
Component:	Skylights
Location:	Central corridors of original portion of the building
Deficiency:	Cracked plexi-glass domes or leaking seals. Poor quality product with minimal thermal resistance.
Consequence:	Observable water leakage at interior ceilings adjacent to skylights. Excessive heat loss/heat gain as a result of poor quality skylight.
Photo #3.1G-EL

Recommendation:	<p>Remove and replace sixteen (16) existing poor efficiency dome skylights with modern thermally efficient translucent skylights.</p> <p>Skylights typically result in 35%-45% greater heat losses during cold weather compared to windows of that same material, construction, and sizes. Increased convection and radiation heat transfers and the increased surface area associated with the skylight curb all contribute to this increase in energy loss. Skylight can be made of glass or a variety of plastics. Glass while more durable is limited to a flat or planar shape. The dome or ridge shaped</p>

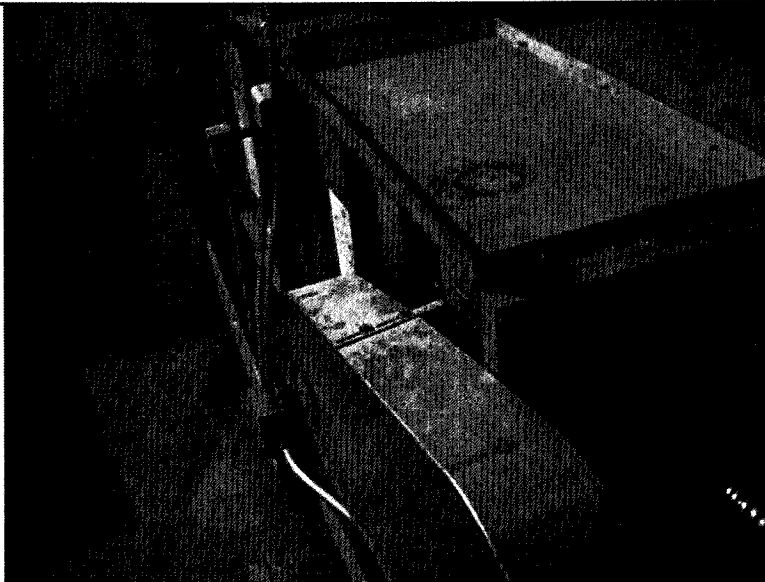
Item # 5M-HS	Description
Component:	Central air-handler; fan belt, sheaves and bearings
Location:	Shops building attic
Deficiency:	Rotating fan/motor imbalance
Consequence:	Noise, unreliable service life
Photo #5M-HS

Recommendation:	<p>Replace fans, sheaves, belts, and bearings in existing air handling unit. Rebalance existing air system.</p> <p>By replacing the fans, sheaves, belts, and bearings in the existing air handling unit is will be return to its original state.</p>
Cost Estimate:	\$1,417
Priority:	High
